FORT SHERIDAN  
ORDNANCE SURVEY (50 - ACRE PARCEL)

## FINAL TECHNICAL REPORT

**FORMER FORT SHERIDAN  
UNEXPLODED ORDNANCE SURVEY**

**FINAL TECHNICAL REPORT**

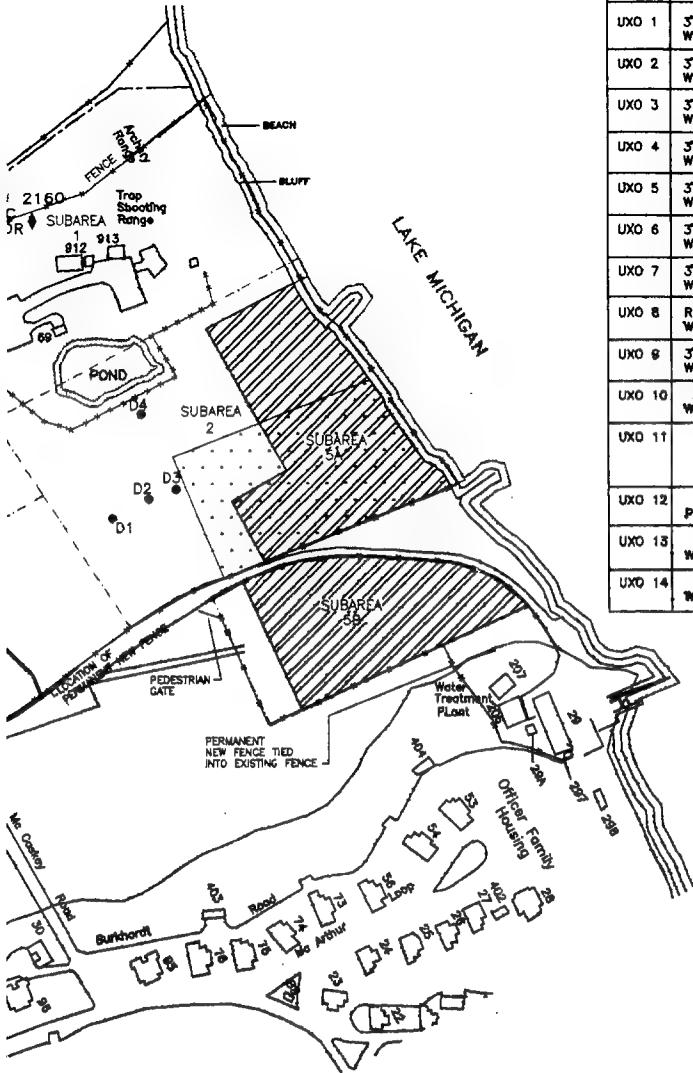
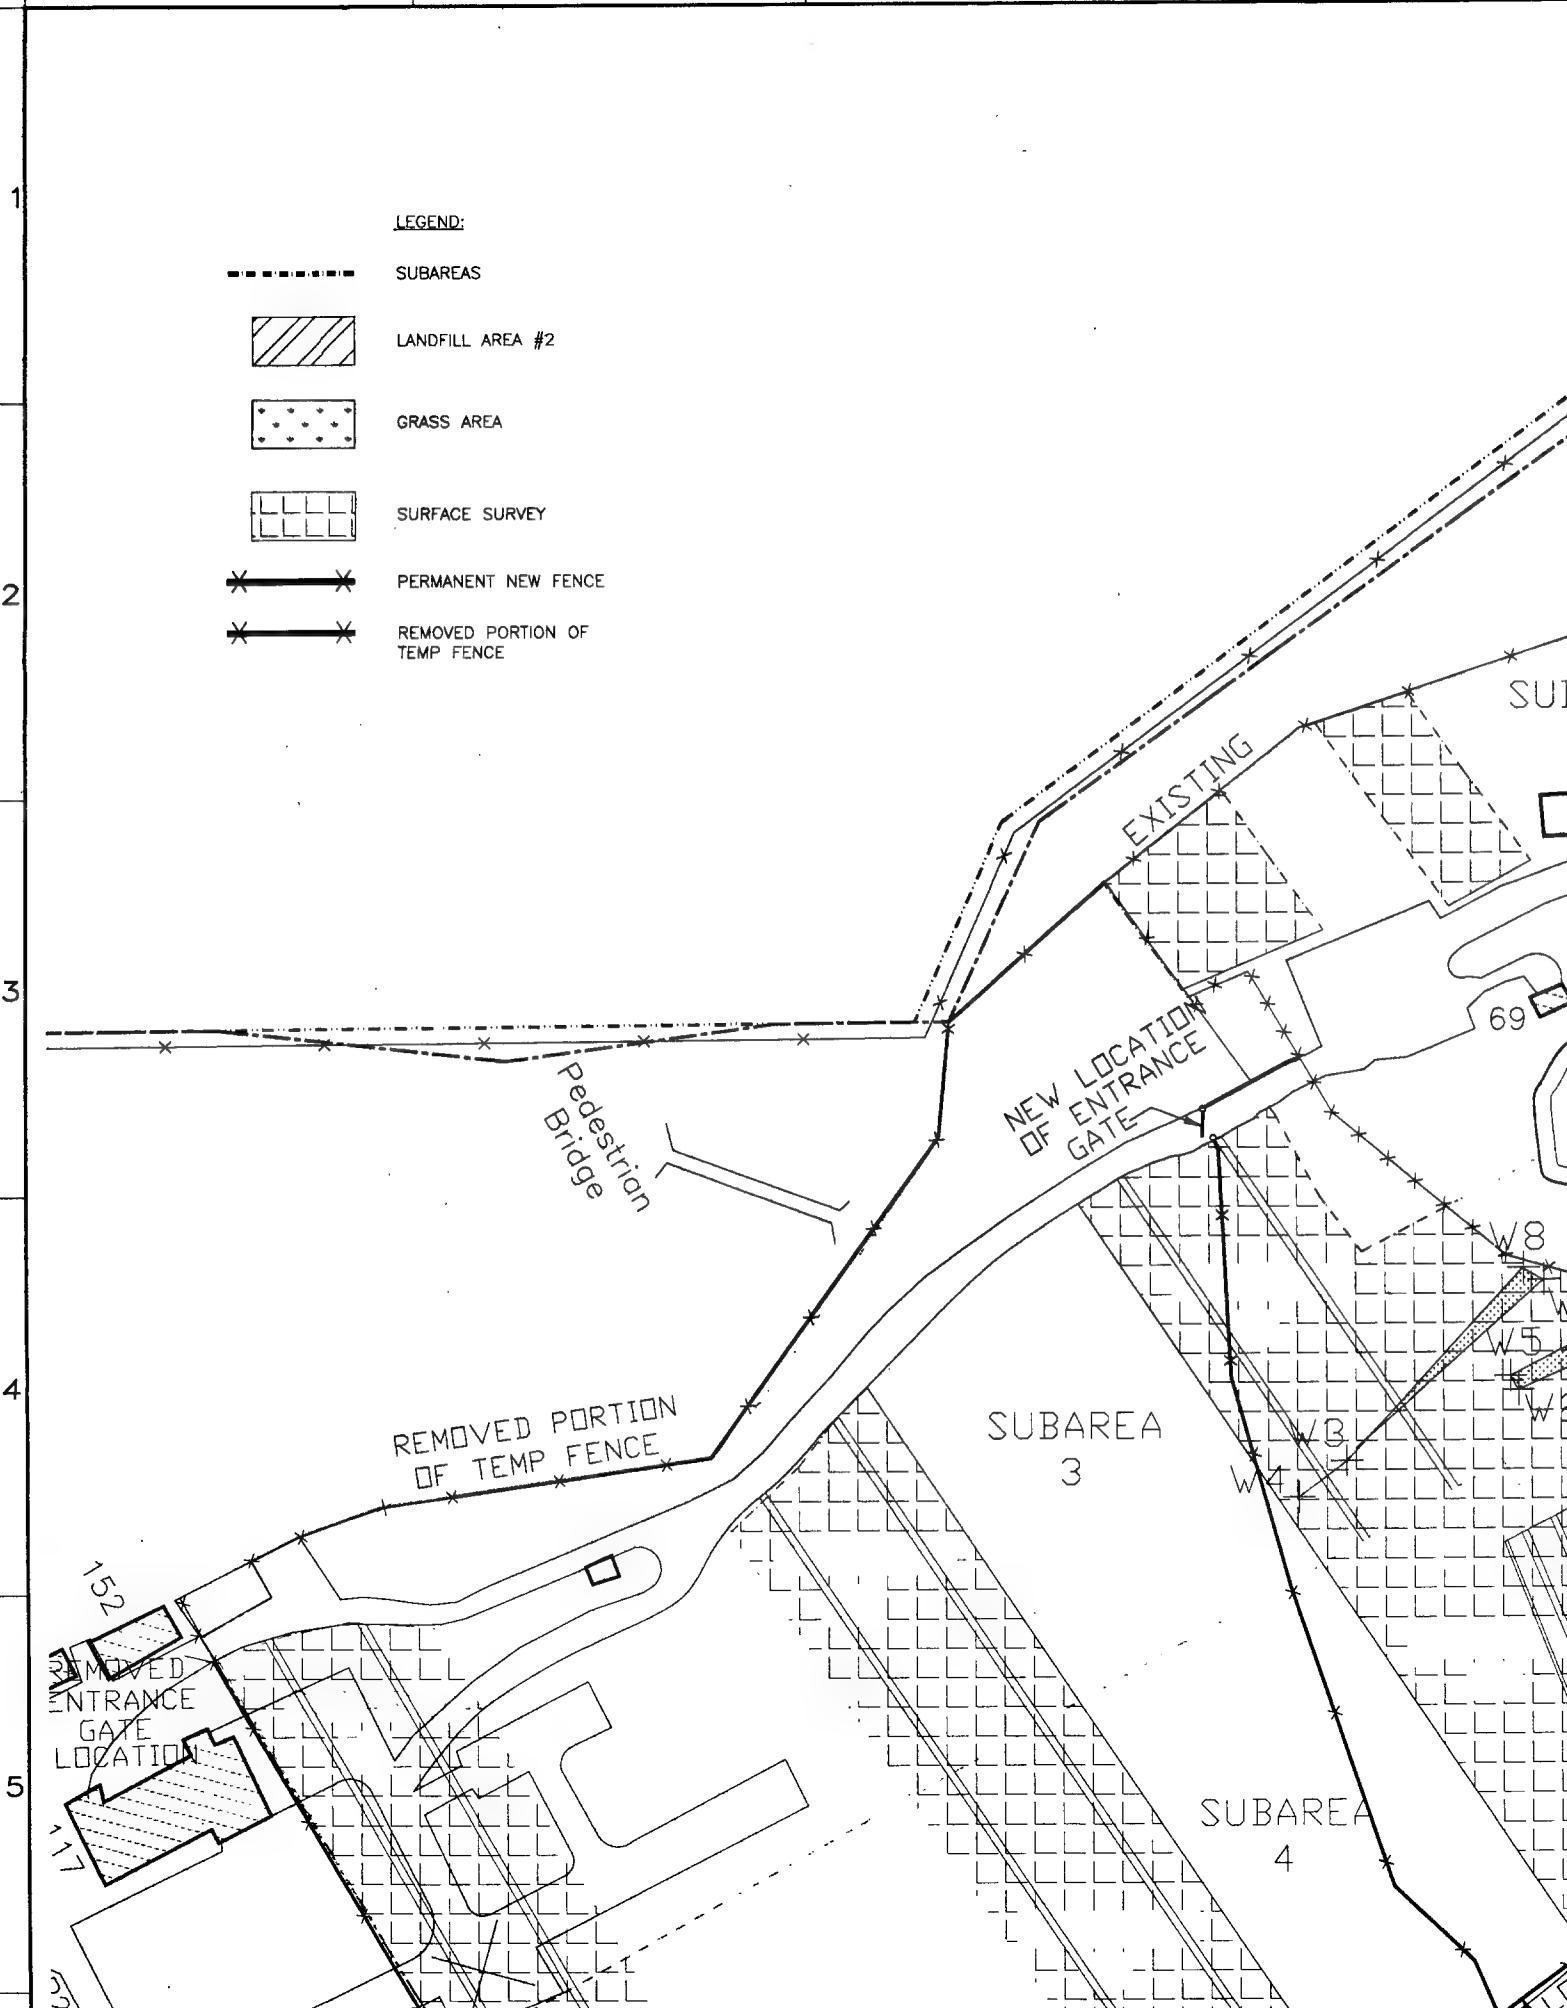
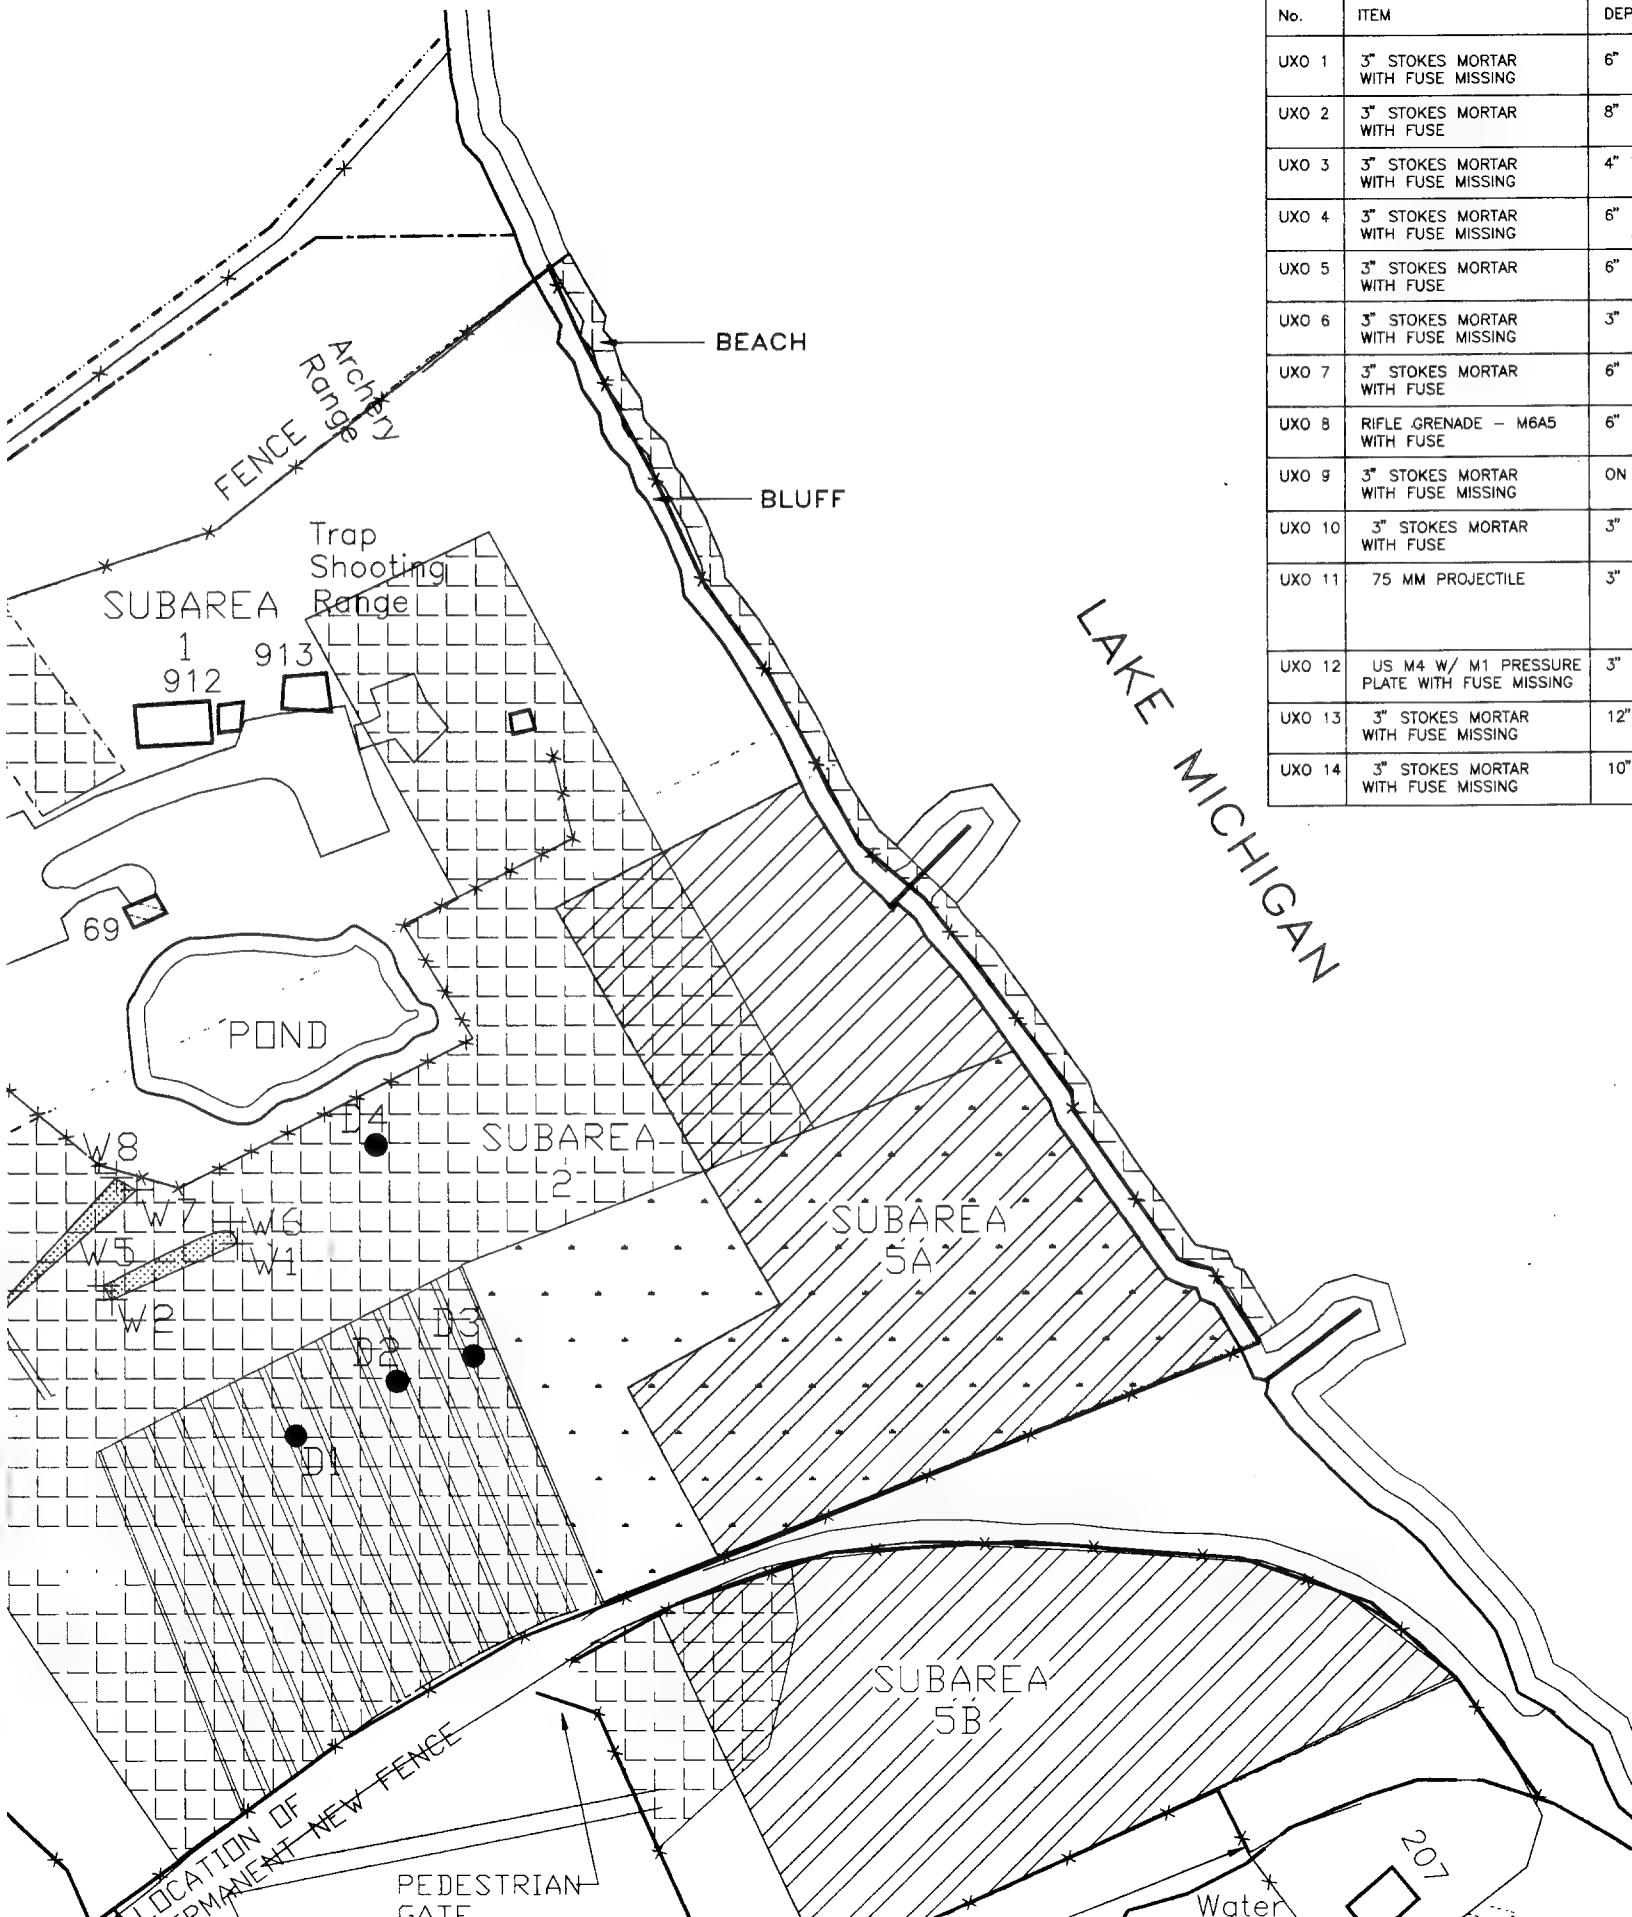
Each UXO found was entered into the project UXO accountability system. Each UXO was assigned a sequential identification number, and all data pertaining to the UXO was recorded on a UXO Accountability Log sheet. The UXO Accountability Log was used to track all movement of the UXO until final disposal of the UXO by military EOD. Appendix B lists all UXO found during the project by sequential accountability number. The UXO Accountability Log sheets are included as Appendix C. The location of each UXO found is documented in Figure 6.

No.	ITEM	DEPTH FOUND AT	DETONATION SITE	STATE PLANAR COORDINATES NAD 83		LATITUDE	LONGITUDE
				(X) EASTING	(Y) NORTHING		
UXO 1	3" STOKES MORTAR WITH FUSE MISSING	6"	D1	1420739.2859	15337792.1894	78° 35' 24.84"	082° 18' 03.47"
UXO 2	3" STOKES MORTAR WITH FUSE	8"	D1	1420644.5792	15337741.4385	78° 35' 24.44"	082° 18' 08.40"
UXO 3	3" STOKES MORTAR WITH FUSE MISSING	4"	D1	1420627.1332	15337872.9751	78° 35' 25.74"	082° 18' 08.59"
UXO 4	3" STOKES MORTAR WITH FUSE MISSING	6"	D1	1420702.7324	15337911.8143	78° 35' 28.04"	082° 18' 04.66"
UXO 5	3" STOKES MORTAR WITH FUSE	6"	D1	1420837.3157	15337941.3321	78° 35' 26.20"	082° 17' 57.86"
UXO 6	3" STOKES MORTAR WITH FUSE MISSING	3"	D4	1420720.1784	15338013.3142	78° 35' 27.02"	082° 18' 03.28"
UXO 7	3" STOKES MORTAR WITH FUSE	6"	D4	1420688.6713	15337986.3887	78° 35' 28.81"	082° 18' 05.95"
UXO 8	RIFLE GRENADE - M6A5 WITH FUSE	6"	D4	1420810.7313	15337816.0108	78° 35' 25.00"	082° 17' 59.81"

UXO 9	3" STOKES MORTAR WITH FUSE MISSING	ON SURFACE	D2	1420842.3002	15337583.4932	78° 35' 22.68"	082° 17' 59.44"
UXO 10	3" STOKES MORTAR WITH FUSE	3"	D2	1420735.1321	15337523.9387	78° 35' 22.22"	082° 18' 05.04"
UXO 11	75 MM PROJECTILE	3"	TRANSPORTED BY 88b EOD TEAM TO FT. McCOY, WI.	1420766.9014	15338484.4006	78° 35' 31.58"	082° 17' 58.55"
UXO 12	US M4 W/ M1 PRESSURE PLATE WITH FUSE MISSING	3"	D1	1420788.6144	15338377.1898	78° 35' 30.51"	082° 17' 58.03"
UXO 13	3" STOKES MORTAR WITH FUSE MISSING	12"	D3	1420745.2748	15337846.1538	78° 35' 23.40"	082° 18' 03.92"
UXO 14	3" STOKES MORTAR WITH FUSE MISSING	10"	D3	1420509.2004	15337585.5496	78° 35' 23.05"	082° 18' 15.89"

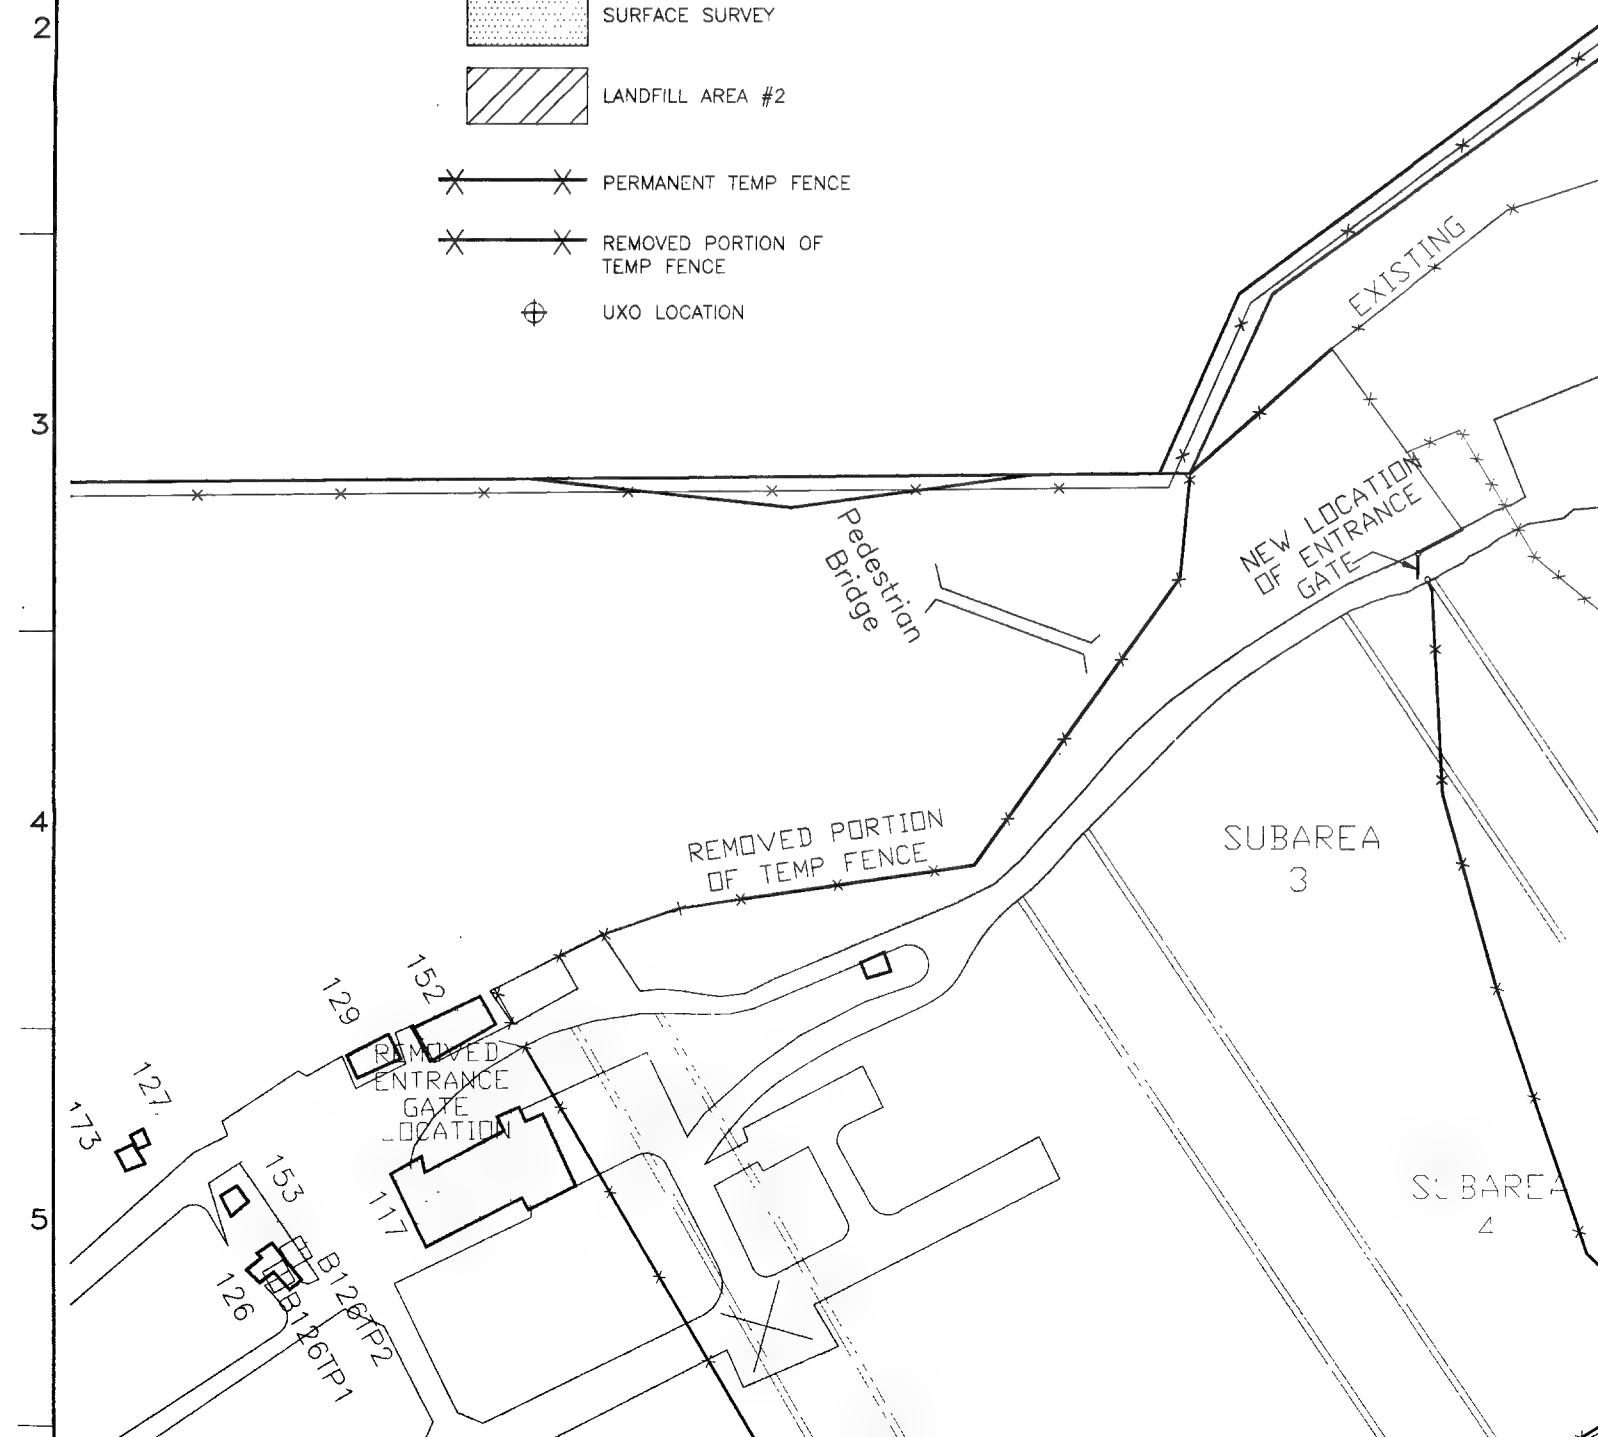
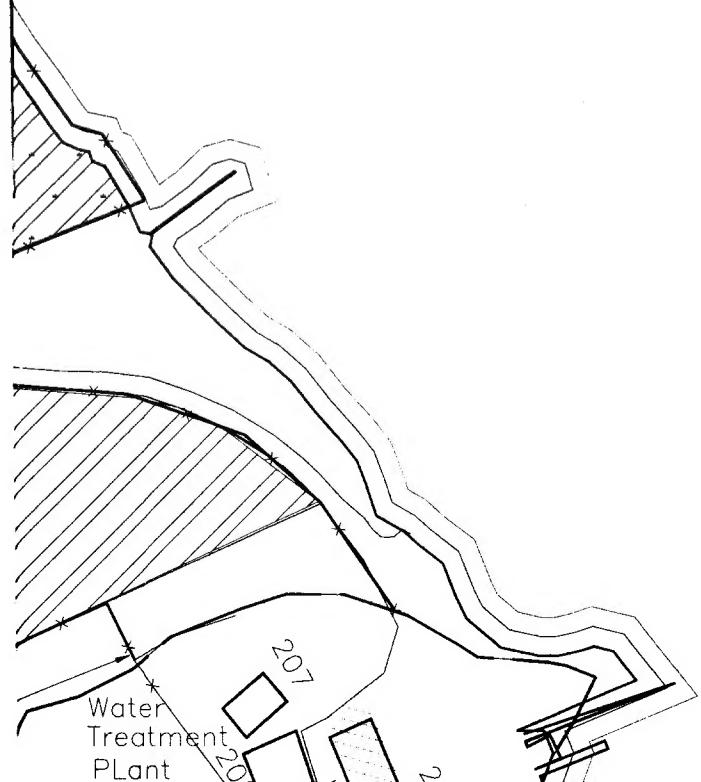
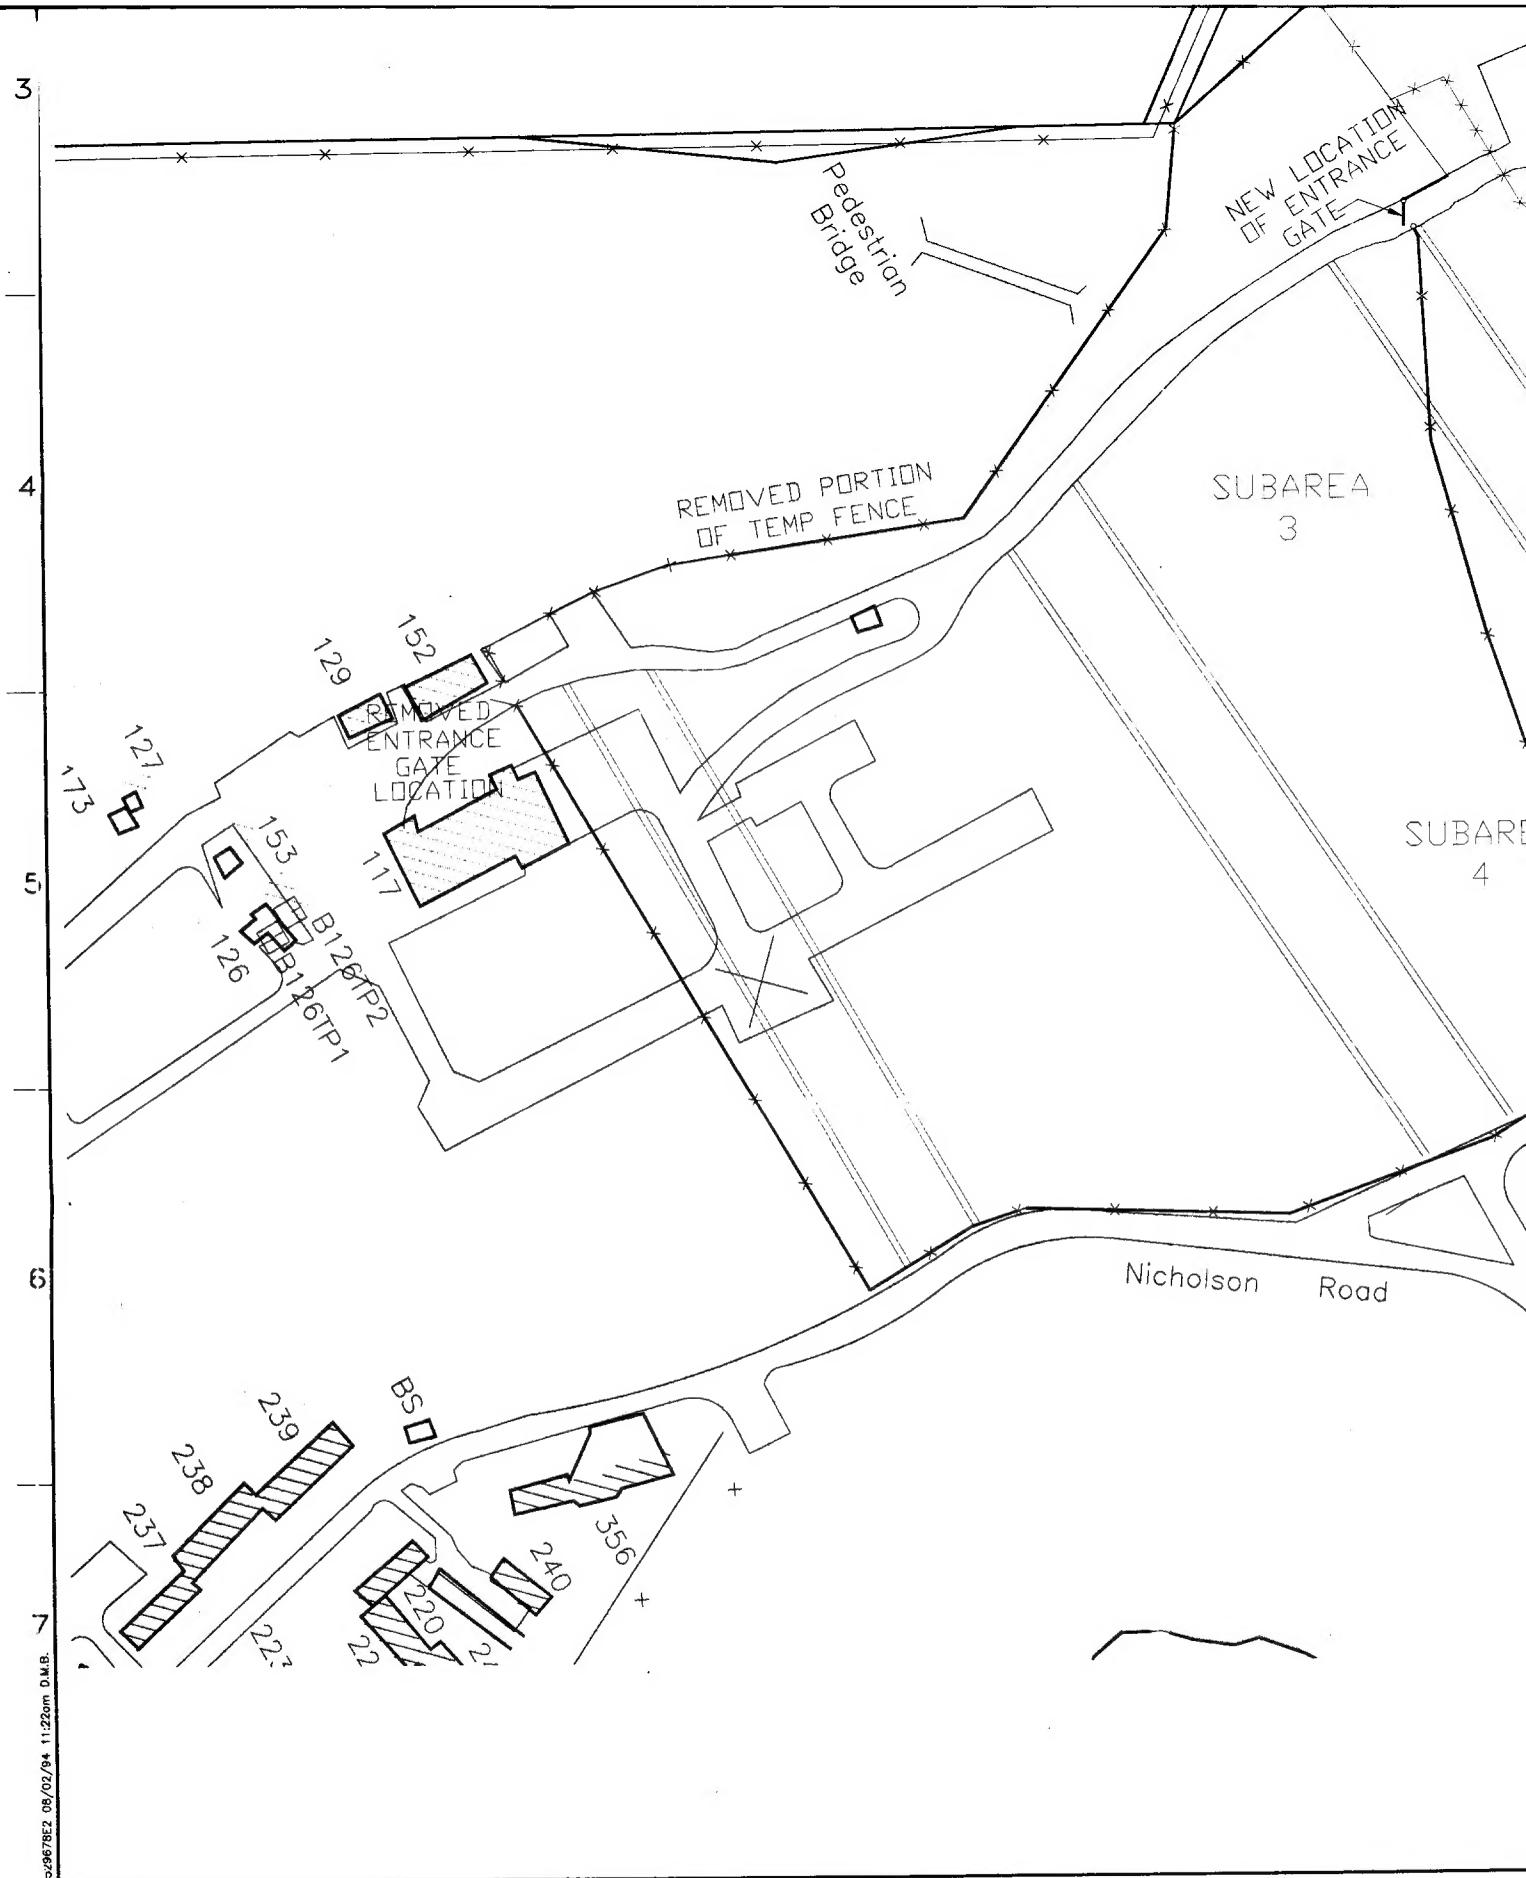
No.	ITEM	DEPTH FOUND AT
UXO 1	3" STOKES MORTAR WITH FUSE MISSING	6"
UXO 2	3" STOKES MORTAR WITH FUSE	8"
UXO 3	3" STOKES MORTAR WITH FUSE MISSING	4"
UXO 4	3" STOKES MORTAR WITH FUSE MISSING	6"
UXO 5	3" STOKES MORTAR WITH FUSE	6"
UXO 6	3" STOKES MORTAR WITH FUSE MISSING	3"
UXO 7	3" STOKES MORTAR WITH FUSE	6"
UXO 8	RIFLE GRENADE - M6A5 WITH FUSE	6"
UXO 9	3" STOKES MORTAR WITH FUSE MISSING	ON SURFACE
UXO 10	3" STOKES MORTAR WITH FUSE	3"
UXO 11	75 MM PROJECTILE	3"
UXO 12	US M4 W/ M1 PRESSURE PLATE WITH FUSE MISSING	3"
UXO 13	3" STOKES MORTAR WITH FUSE MISSING	12"
UXO 14	3" STOKES MORTAR WITH FUSE MISSING	10"
